Property Inspection Report

Elite Inspection Services, Inc.

Inspection Date: 8/30/2019

Structure Type: Single Family

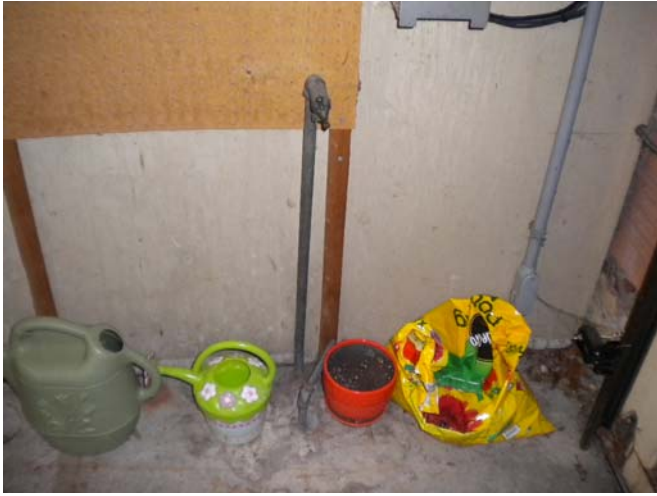
Abandoned piping in garage

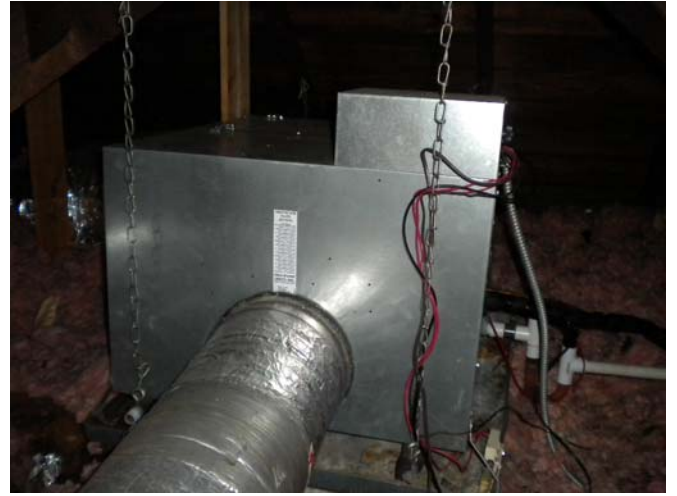
Attic air handler

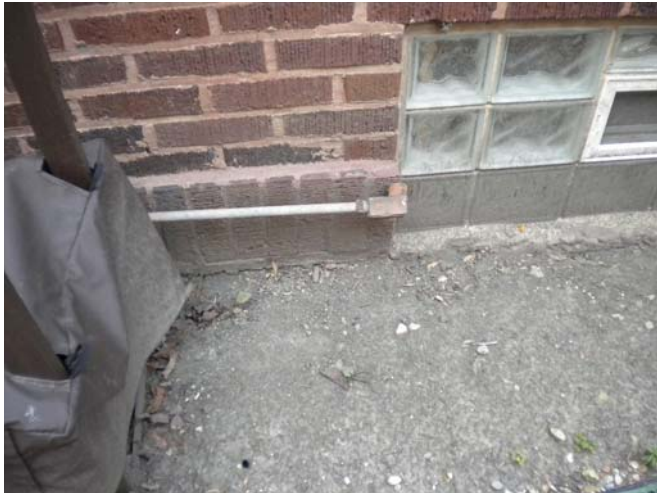
Type: Conduit, BX, Romex
Conditions: **Abandoned Wiring** --- Abandoned wires, wire sheathing, or conduit were observed at one or more locations. Further evaluation of apparently abandoned wires is recommended by a qualified electrician and remove as necessary.
Location: exterior east side of house south of A/C units.
Open Junction Box --- One or more junction boxes (electrical connection boxes) were noted without a proper cover. This may create a potential safety hazard. Covering of all open junction boxes is recommended with a proper fitting cover.
Location: basement furnace room ceiling above boiler.
Romex Not In Conduit --- Plastic sheathed wiring (Romex) was noted in one or more areas. This type of wiring is typically not allowed for use in this area. Recommend further evaluation of the electrical branch system by a qualified electrician and correct/repair as necessary.
Location: basement furnace room ceiling just west of boiler.

Abandoned wiring

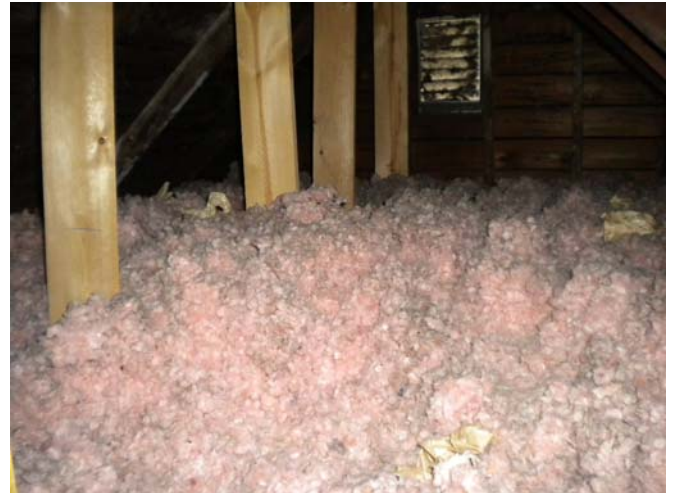
Attic insulation

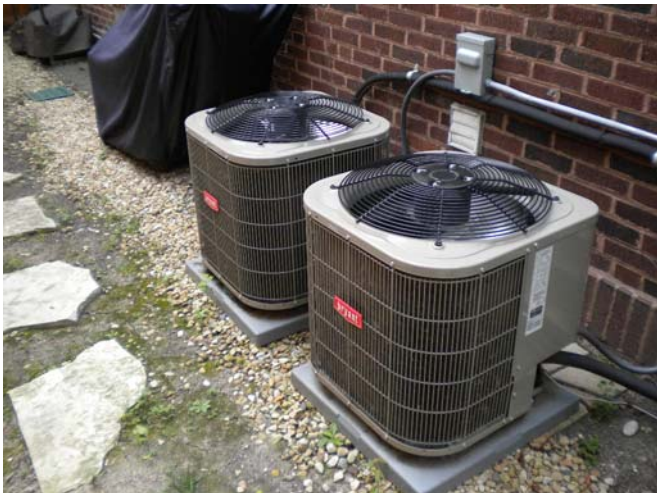
A/C units

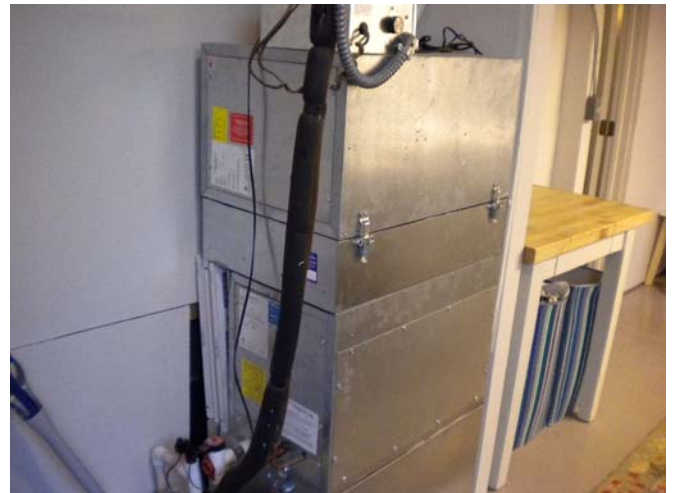
Basement air handler

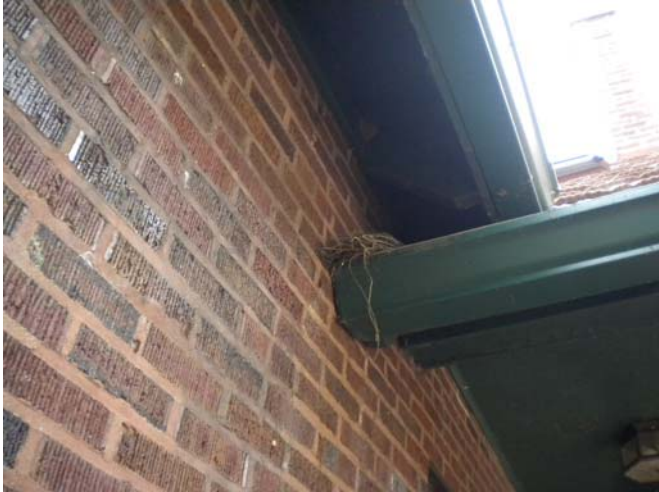
Conditions: **Bird/Animal Nest** --- Bird or animal nest(s) were observed at one or more locations. Further evaluation by a qualified animal control specialist is recommended to determine occupancy of nest(s) and properly remove nest(s) and animal(s) if present. Location: north side of house above basement stairwell.

Birds nest

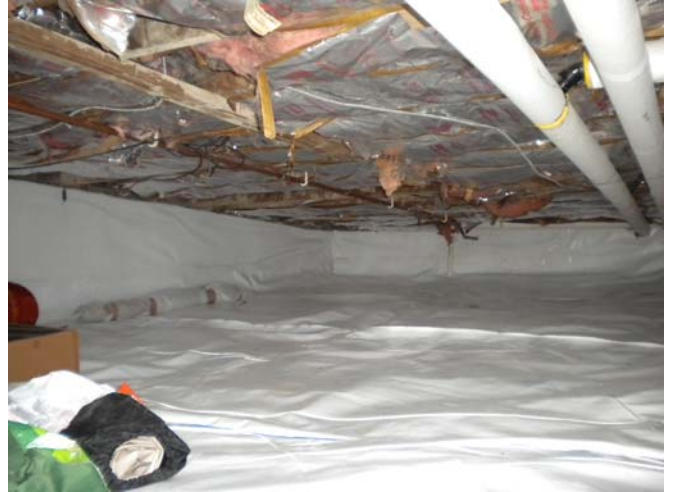
Crawlspace

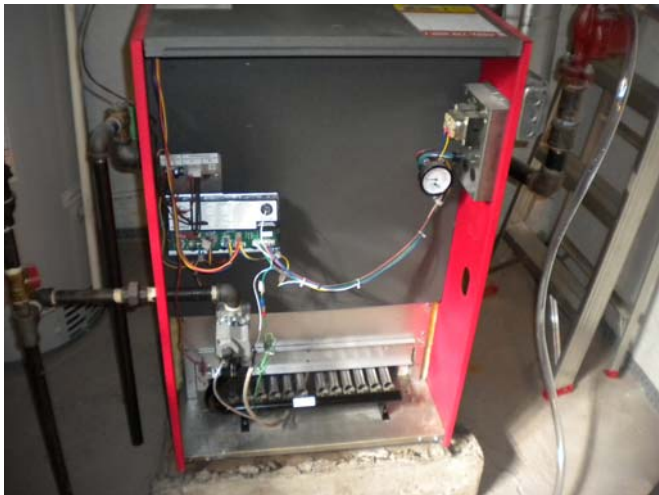
Boiler

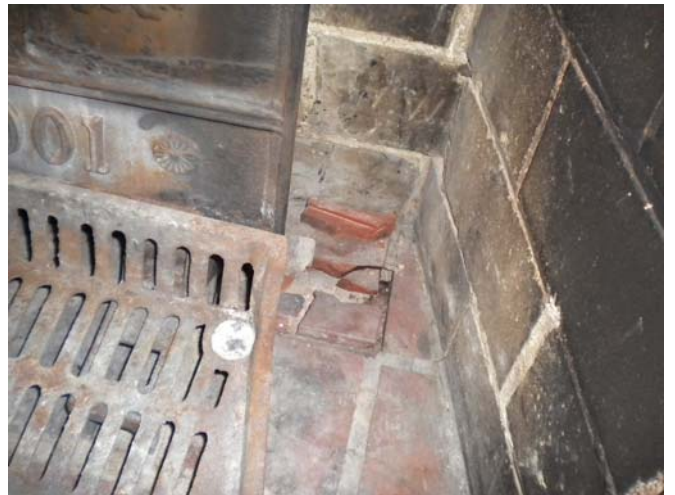
Damaged brick in fireplace

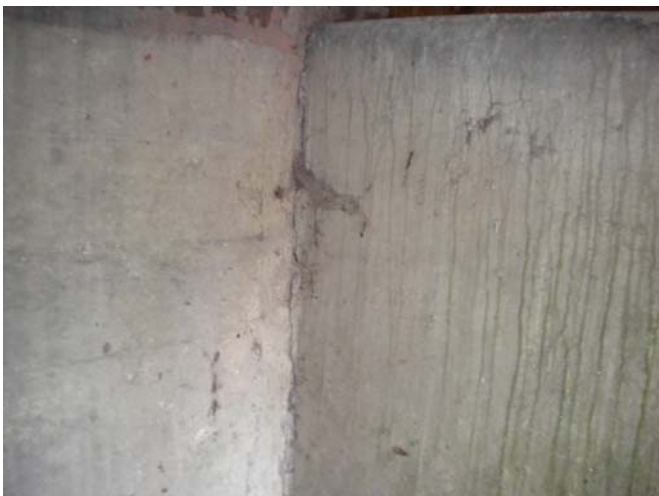
Cracking at stairwell

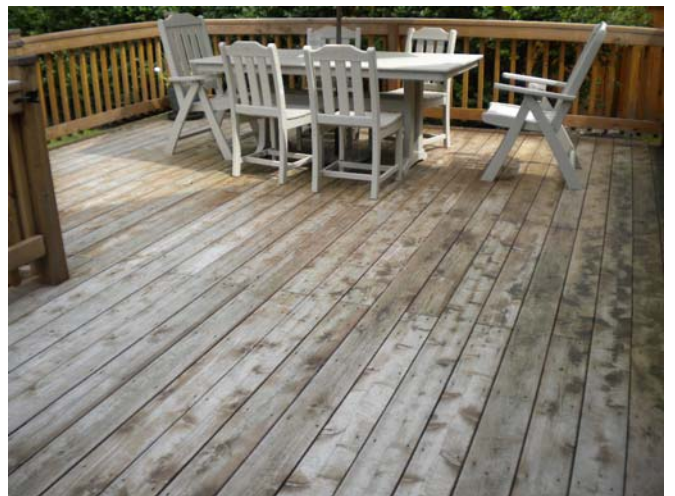
Deck

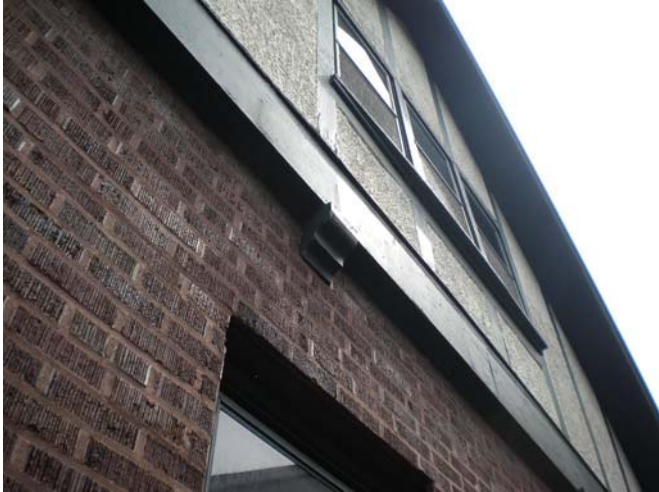
Conditions: **Engineer Evaluation Recommended** --- Signs of movement, settlement, or possibly inadequate construction was observed in one or more locations. This may adversely affect the building. Further evaluation by a qualified structural engineer is recommended.

Location: deflection was observed at the west wall above the kitchen area. Exact reason for deflection was undetermined. Recommend evaluation of this area by a qualified structural engineer.

Deflection at west wall

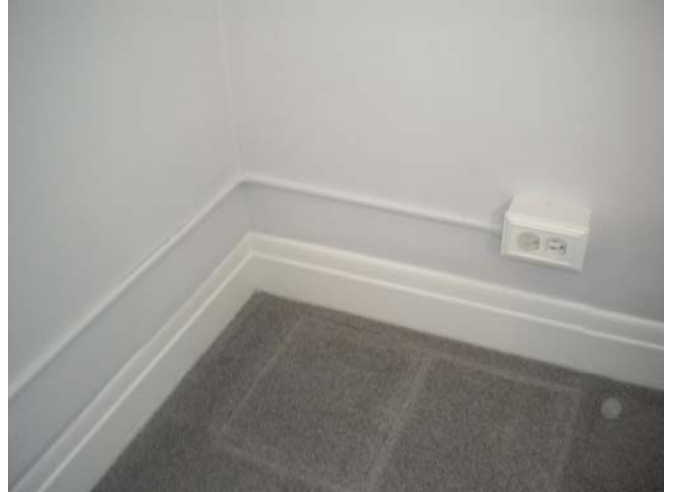
Surface Mounted Electric Raceway --- Surface-mounted electric channel was present in one or more locations. This type of wiring can be used in certain conditions however is not a typical installation. Recommend evaluation by a qualified electrician for information and repair solutions.
Location: upper level east bedroom north and east walls and upper level loft area west and south walls.

Exposed electric raceway

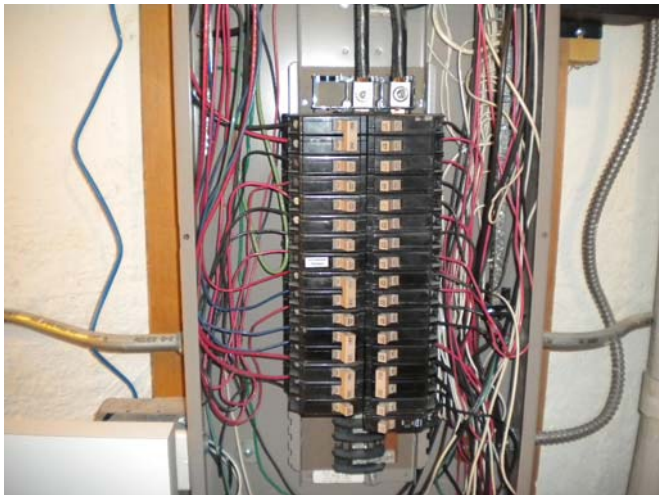
Electric panel

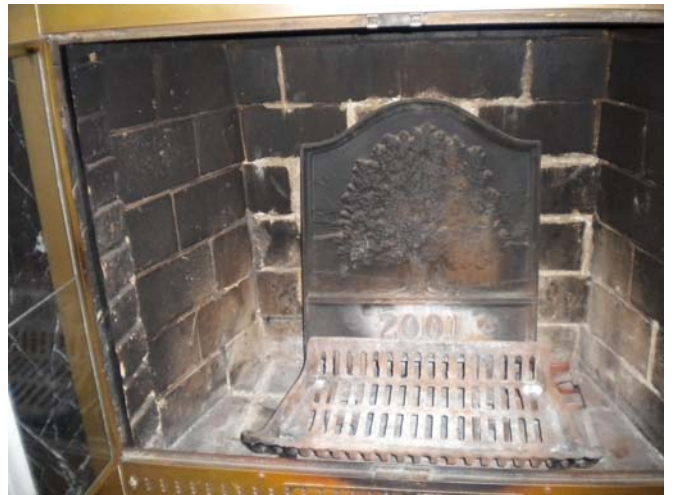
Fireplace

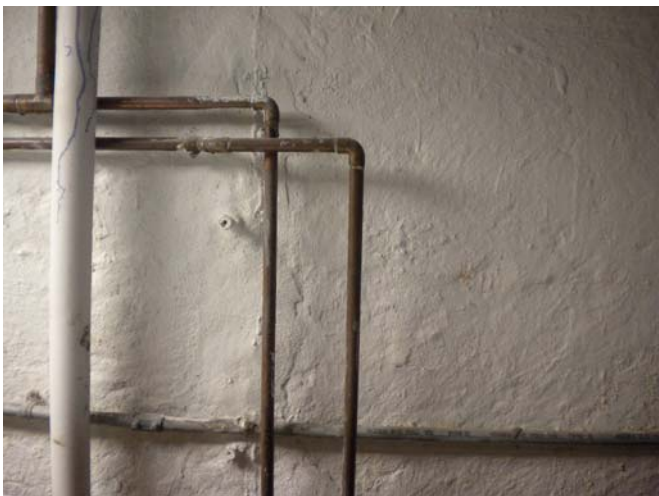
Epoxy grouted foundation crack

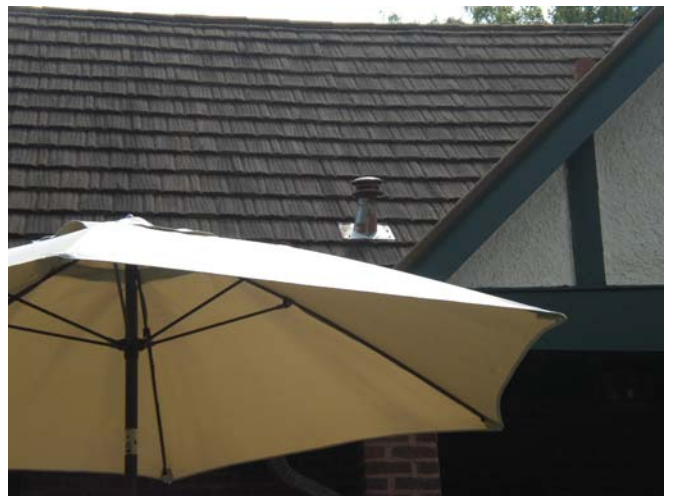
Conditions: **Flashing(s) Improperly Installed** --- The flashing(s) were observed to be improperly installed in one or more locations. Improperly installed flashings may lead to leaks or water penetration. Recommend further evaluation of flashings by a qualified contractor and correct as necessary. Location: at metal vent at north side of roof just east of NE roof valley.

Flashing improper

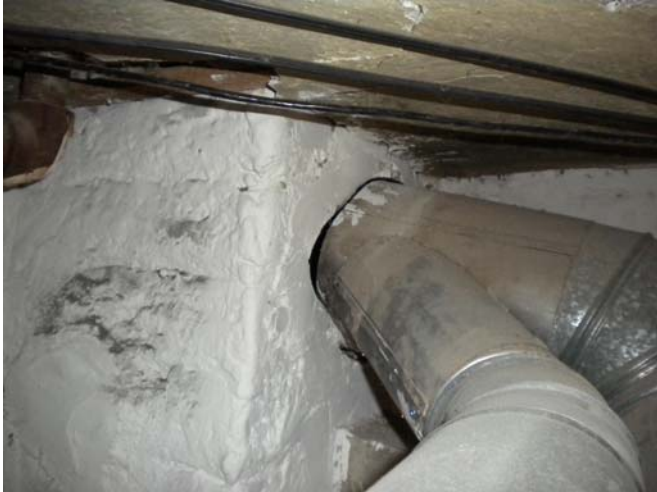
Flue gap at chimney

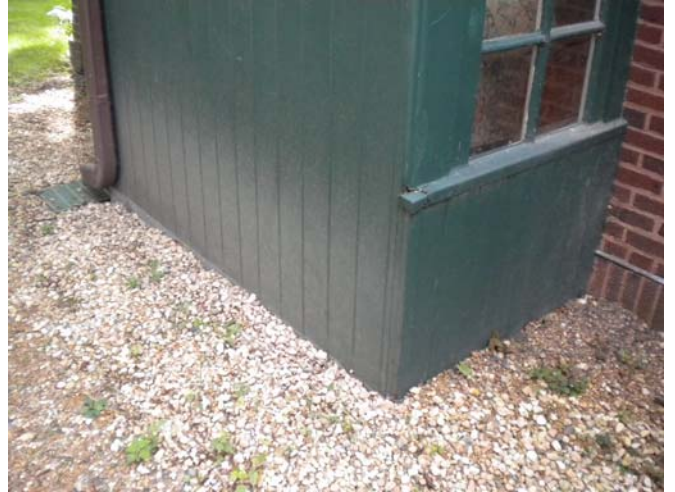
- Site:** Level
Conditions: **Grade Above Finish Surface(s) ---** The grade or soil was above the level of the finish surfaces or siding. This may promote rotting (if wood is present) and may increase the chance of entry of wood destroying insects. Proper correction is recommended by qualified tradesman.
Location: east side of house at SE porch area.
Area(s) Of Low Grade --- The grade or ground in one or more areas appears to be low, in a wet location, or may be susceptible to water accumulation. Recommend further evaluation of the grade by a qualified landscape professional and correct as necessary.
Location: the house and yard appears to be lower in grade level than neighboring houses to the east or west.
Underground Drainage System --- An underground drainage/water control system was observed or apparent. These systems can be very complicated and are not able to be evaluated during a typical home inspection.

Grade above finished material

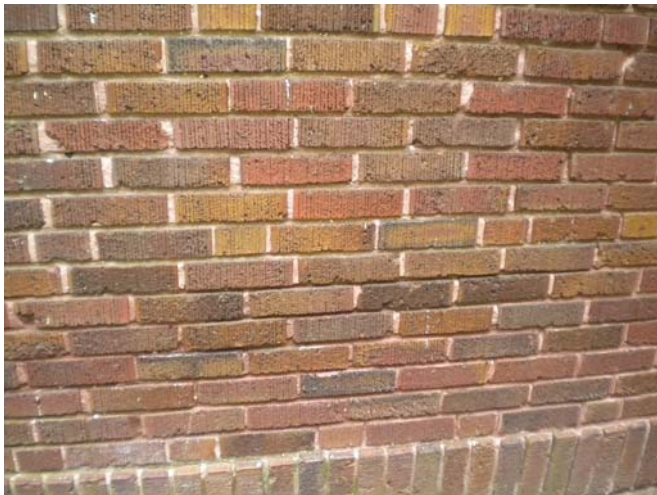
Deteriorated Mortar Joint(s) --- Mortar joints were observed to be deteriorated, damaged, or open in one or more locations. This will likely require repair or tuckpointing. Recommend further evaluation and correction by a qualified masonry contractor.

Garage tuckpointing

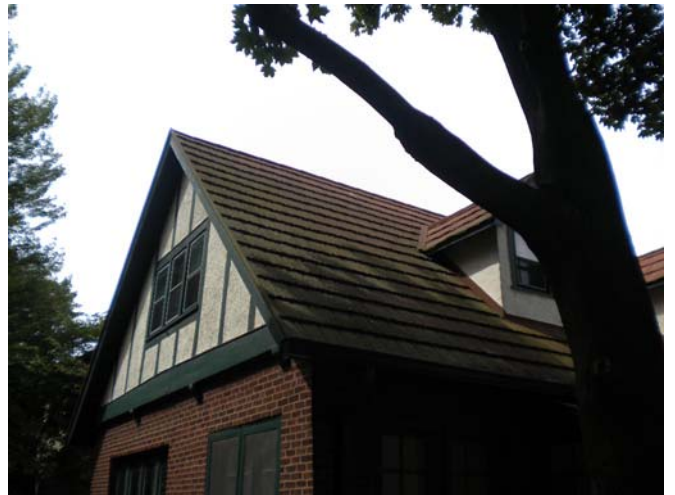
Moss on roof

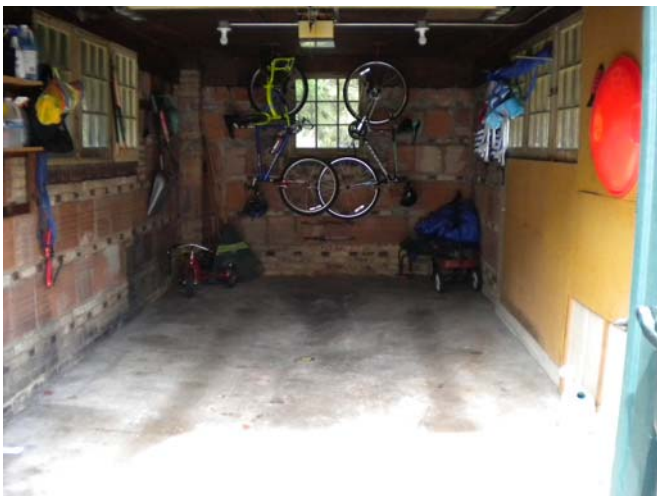
Garage

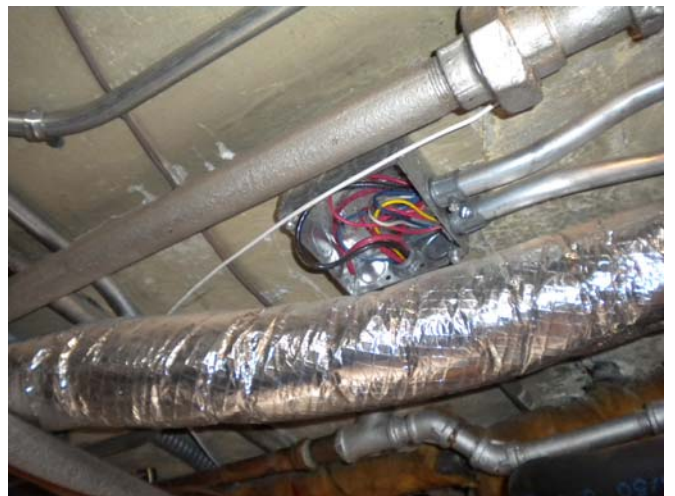
Open junction box

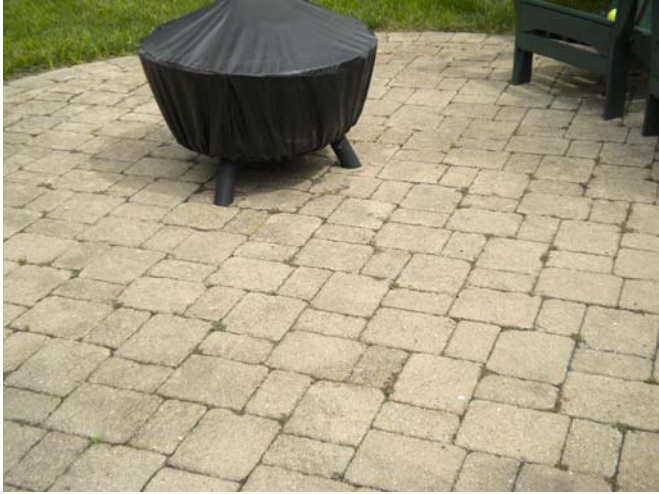
Patio

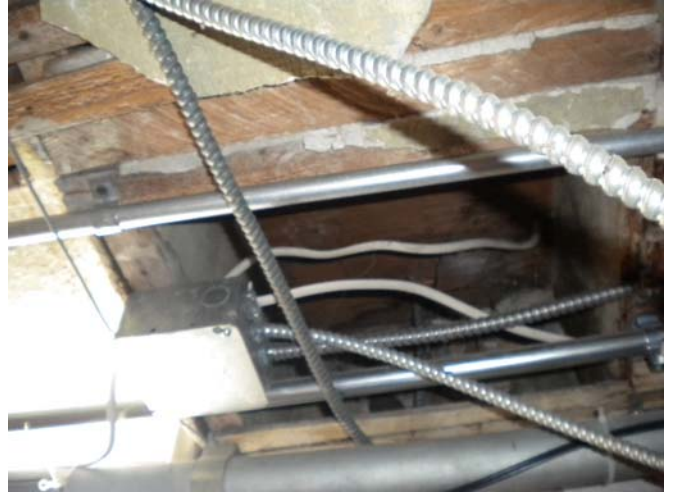
Romex wire

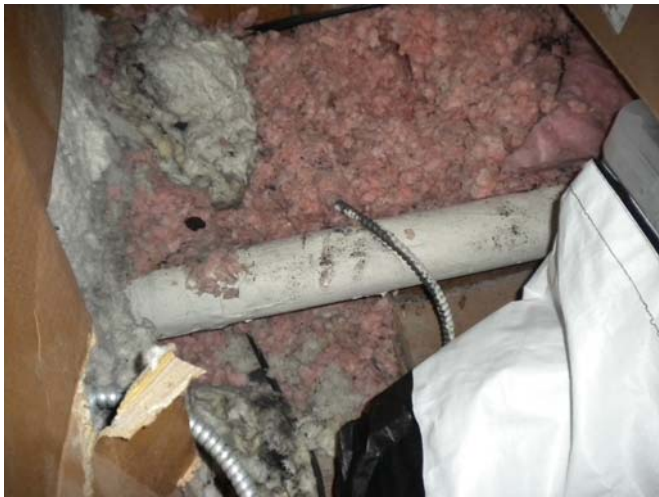
Possible asbestos material

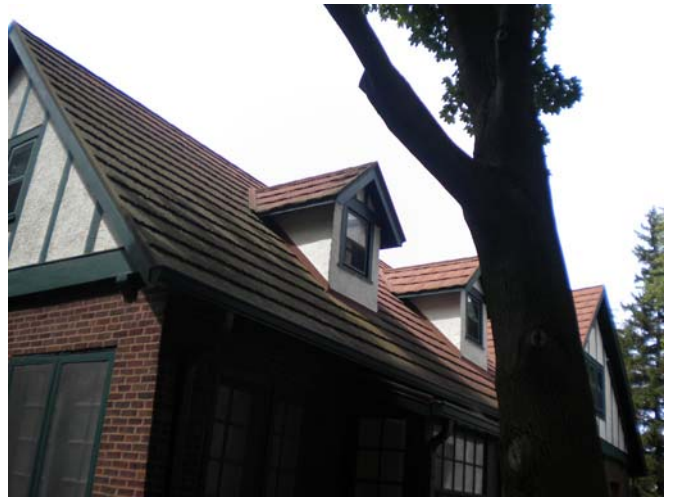
Roof

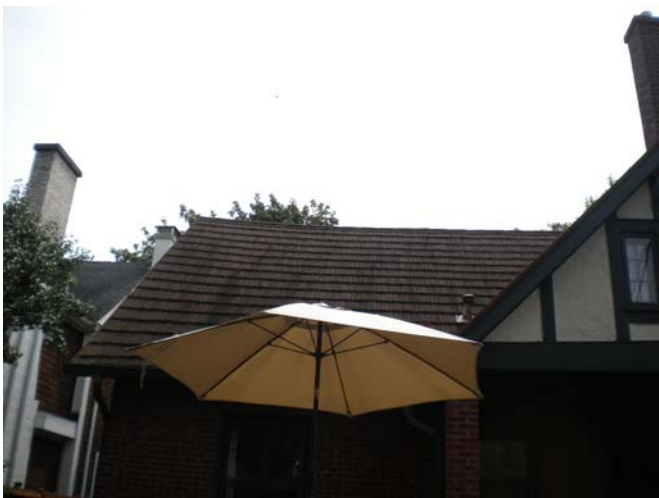
Rafter deflection

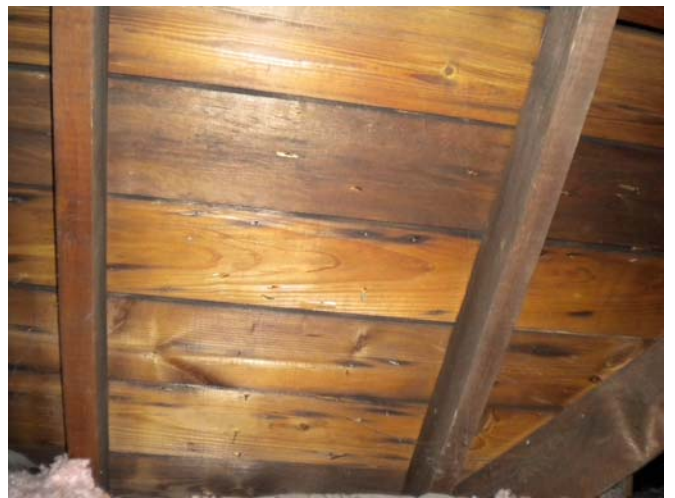
Roof sheathing

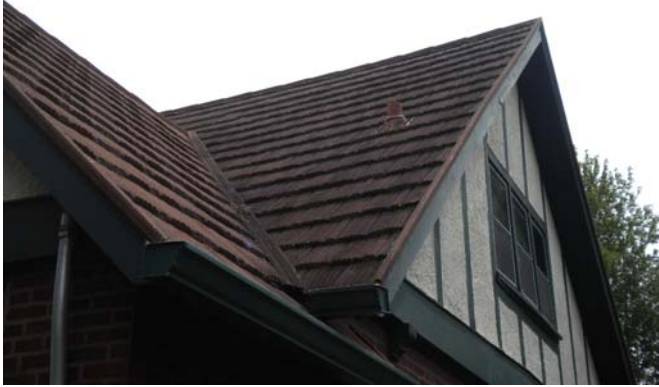
Roof

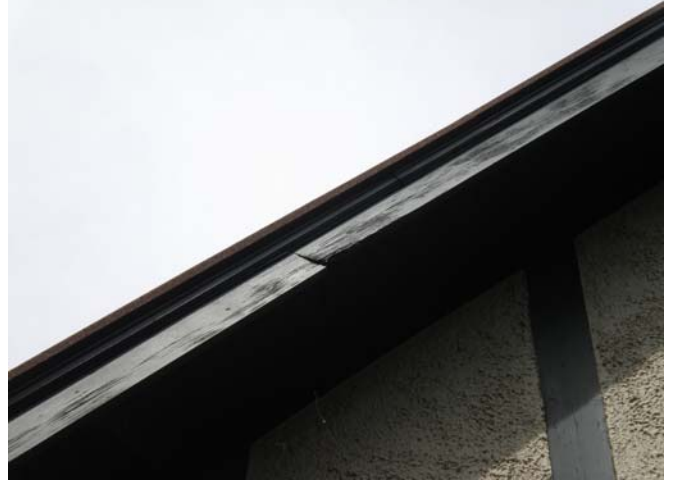
Conditions: **Rotted Wood Fascia(s)** --- Rot was fascia was noted in one or more locations. Rot is the decay of wood in the presence of moisture and fungi. Recommend further evaluation of all trim and proper correction by a qualified contractor. Location: rot noted at wood fascia at multiple locations throughout exterior of house.

Rotted fascia

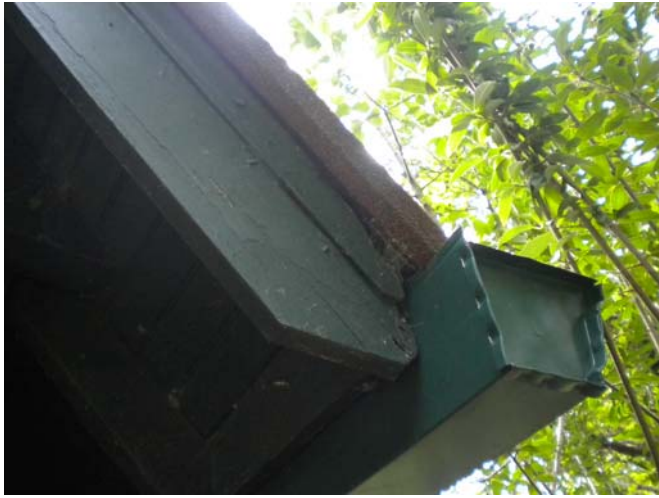
Rotted Wood Trim --- Rot was noted at wood trim at one or more locations. Rot is the decay of wood in the presence of moisture and fungi. Recommend further evaluation of all trim and proper correction by a qualified contractor.

Location: minor rot noted at wood trim at multiple locations.

Rot at garage trim

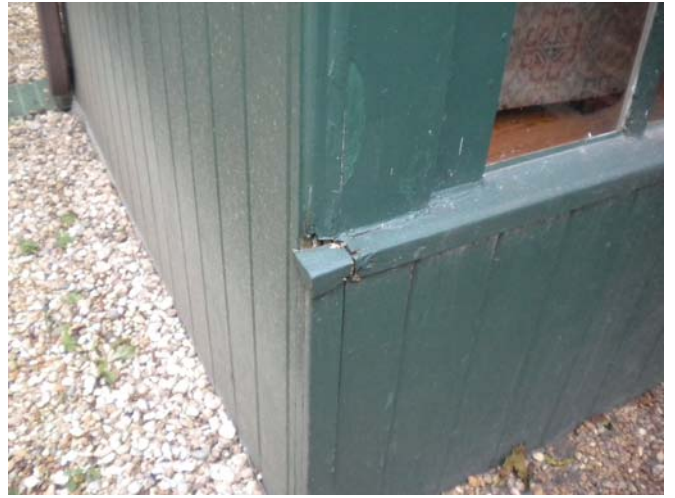
Rotted trim

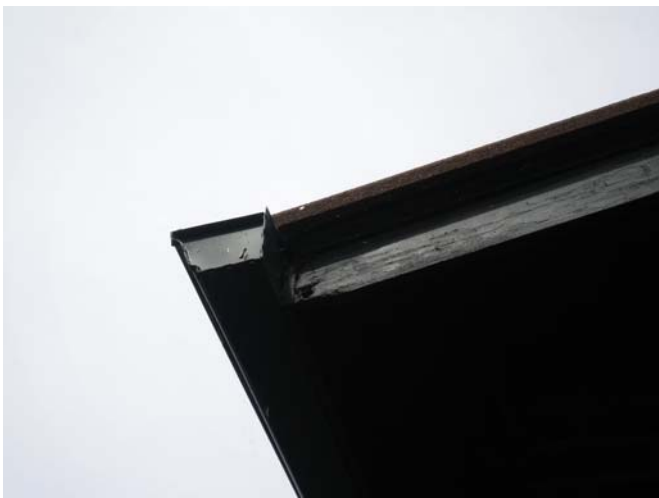
Rot at wood fascia

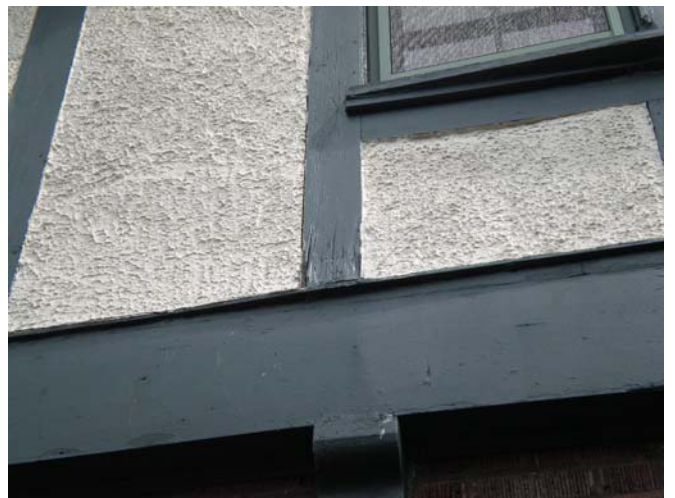
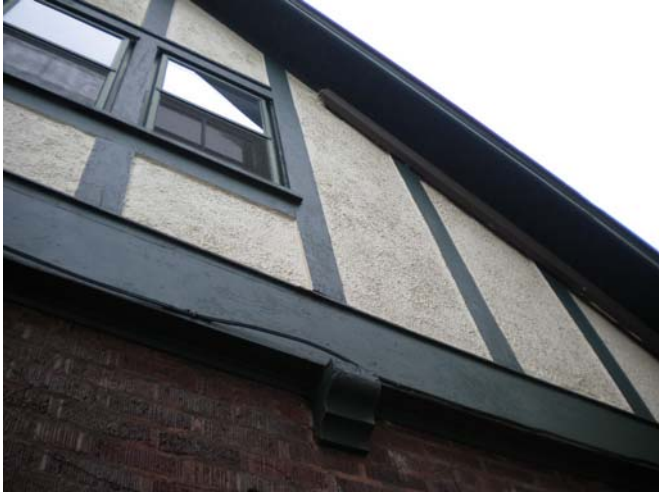
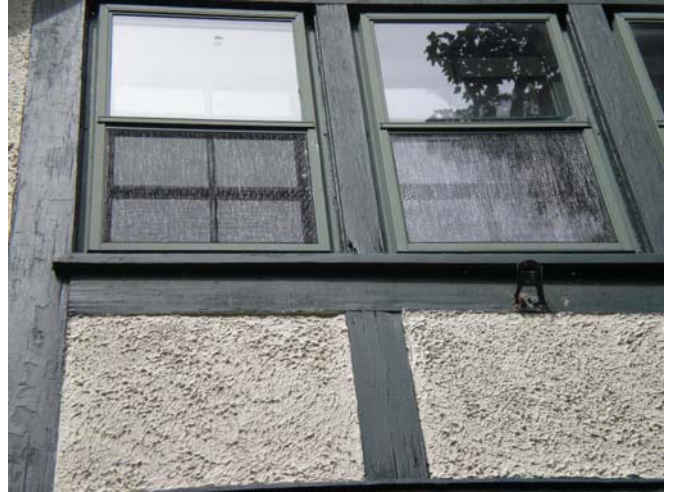
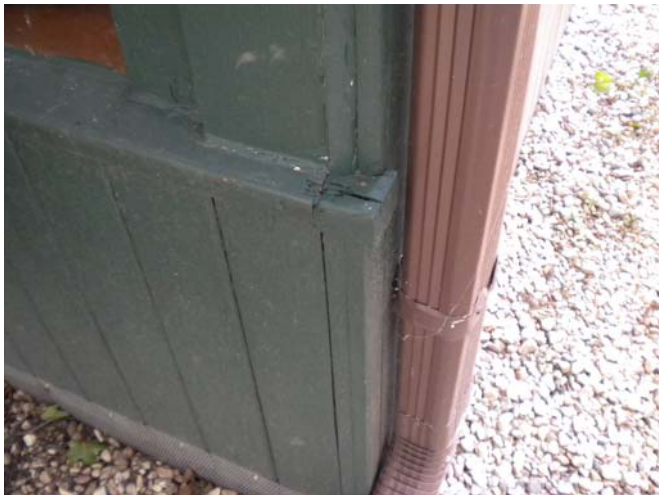
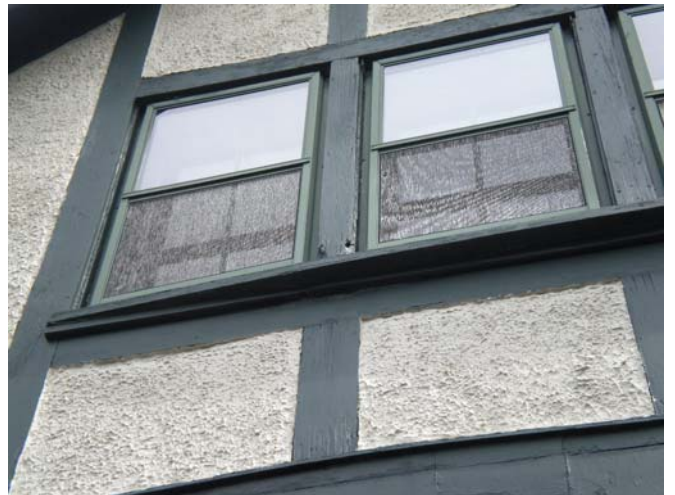
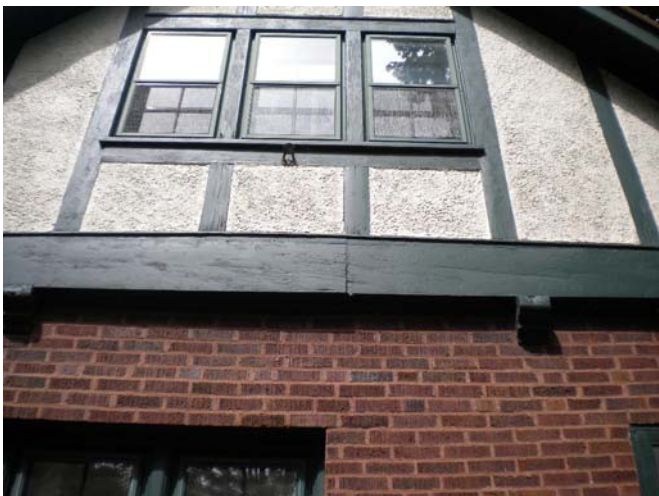
Conditions: **Rotted Wood Trim** --- Rot was noted at wood trim at one or more locations. Rot is the decay of wood in the presence of moisture and fungi. Recommend further evaluation of all trim and proper correction by a qualified contractor.

Location: rot noted at wood trim at multiple locations throughout exterior of house including multiple locations at wood trim pieces within stucco areas.

Rotted wood trim

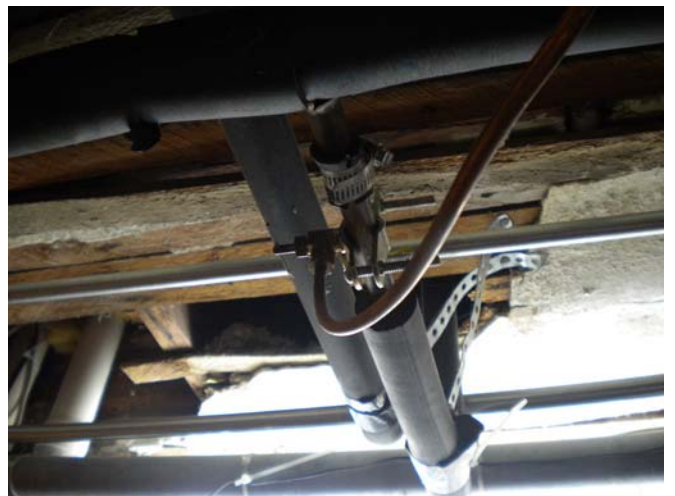
Saddle valve in basement

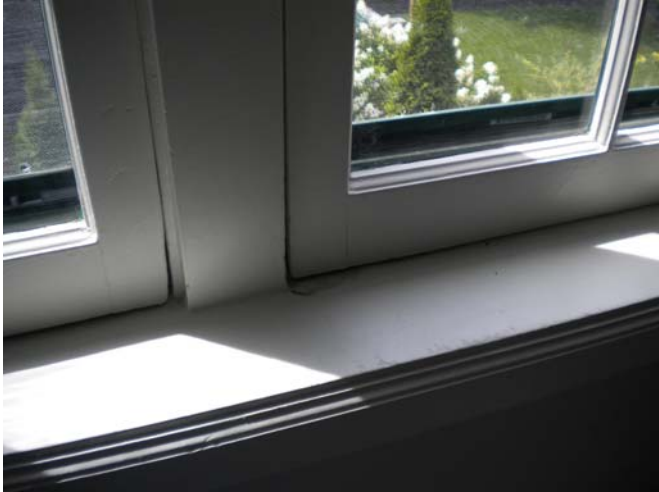
Conditions: **Stained** --- Staining was observed in one or more locations. Recommend further evaluation to determine the source of the stain/staining and correct as necessary. The stained area(s) should be monitored and mold testing should be considered. Location: staining noted at upper level loft area west wall center window.
Window Hardware Missing or Damaged --- The window hardware was missing or damaged in one or more locations. Missing or damaged hardware may not allow for proper function. Repair further evaluation and correction/replacement of affected hardware by a qualified window contractor. Location: missing lock at living room south wall center/west window.
Missing Screen(s) --- One or more screens were missing from the window openings. Proper replacement of all missing screens is recommended. Location: missing screens at multiple locations throughout house.
Cracked or Broken Glass --- One or more panes of glass were cracked or broken. This is potentially dangerous. Further evaluation of all windows and correction is recommended by a qualified window specialist. Location: main level SE bedroom south window.

Staining on window

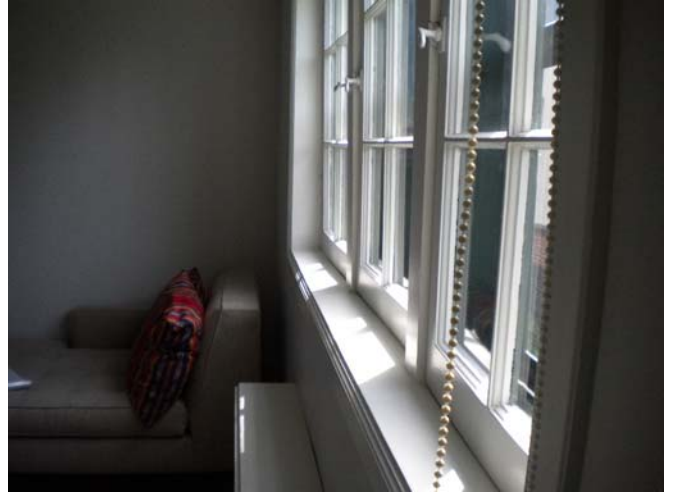
Wall out of plumb

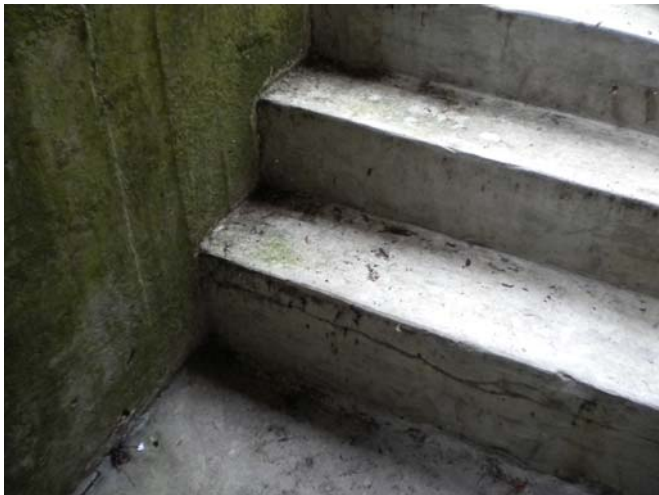
- Sidewalks:** Concrete, Pavers
Conditions: **Reviewed ---** Items in this category were reviewed and appeared serviceable.
- Steps:** Concrete Steps
Conditions: **Unequal Stair Risers/Treads ---** One or more of the stairs risers or treads were of a different dimension than the others which may result in an awkward feel when using the stairs and a possible tripping hazard. Further evaluation and correction by a qualified contractor is recommended.
Location: stairwell steps.
Cracking At Concrete Stairwell --- Cracking and/or settlement was observed at the concrete stairwell walls or slab in one or more locations. Cracking is very

Uneven stairwell steps

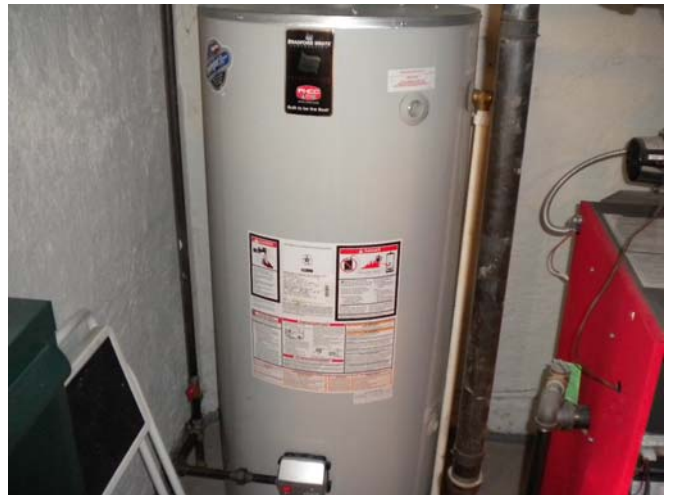
Water heater
